A New Computational Imaging Method for the Remote Detection and Quantification of Hidden Corrosion

The Remote Acoustic/Doppler Technology

Application of the RAID technology to corrosion measurement

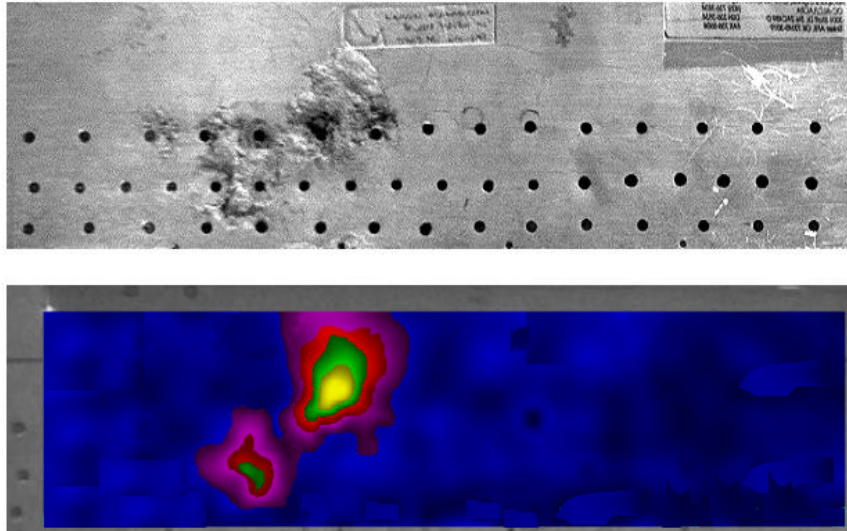
Figure 1: (a) Record of the corroded region, captured from a lap joint panel after destructive inspection. This image was then inverted for ease of comparison with the NDT result. (b) Result of the RAID Doppler scan performed on the exterior of the panel.

As an initial test, a lap joint corrosion sample, removed from a KC-135 lap joint section, was supplied to us by Tinker Air Logistics Command. Figure 1(a) shows the corroded region after the joint had been destructively tested. Figure 1(b) shows the RAID NDT result when scanned from the front or outside of the panel (Note: all our original results are in colour; different colour representing different velocities). It was a first attempt but does show a very fair representation of the corroded region, where up to 20% metal losses were present. Note: Figure 1(a) has been graphically inverted for ease of comparison with Figure 1(b).

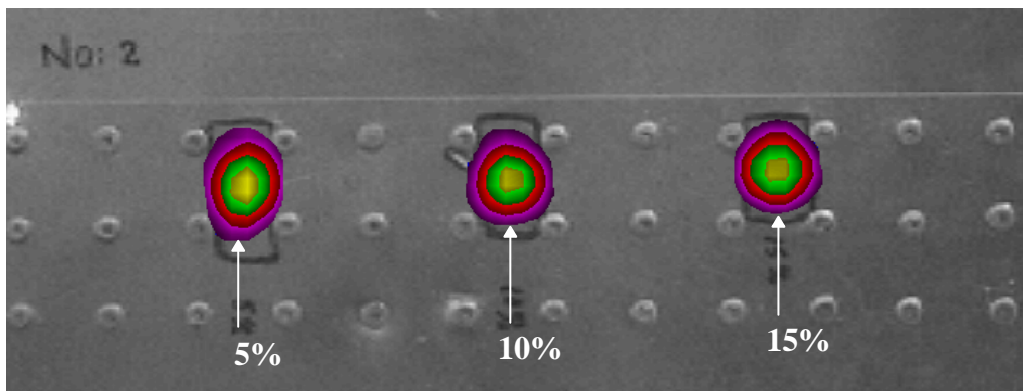
Figure 2: Lab joint panel manufactured with 5%, 10% and 15% metal thinning. Note: all three regions are clearly revealed.

Subsequently, a further complete lap joint was supplied as a blind test in which the system detected corrosion and this was later confirmed by a destructive test. No attempt was made to quantify at this stage of our work. As a result of this test, we made up a lap joint in the laboratory and simulated metal by the removal of metal: 5%, 10%, and 15% respectively. Our in-house developed software analysis program provides what we have termed a “Normalised Selective RMS” function. The algorithm for this software selects only the few recorded FFT frequencies which actually contain data relating to a defect condition and rejects the remainder. This method reduces noise which would otherwise swamp the defect information. The result is illustrated in Figure 2. This result clearly shows all three regions of simulated corrosion spots overlaid on a CCD record of the lap joint sample.

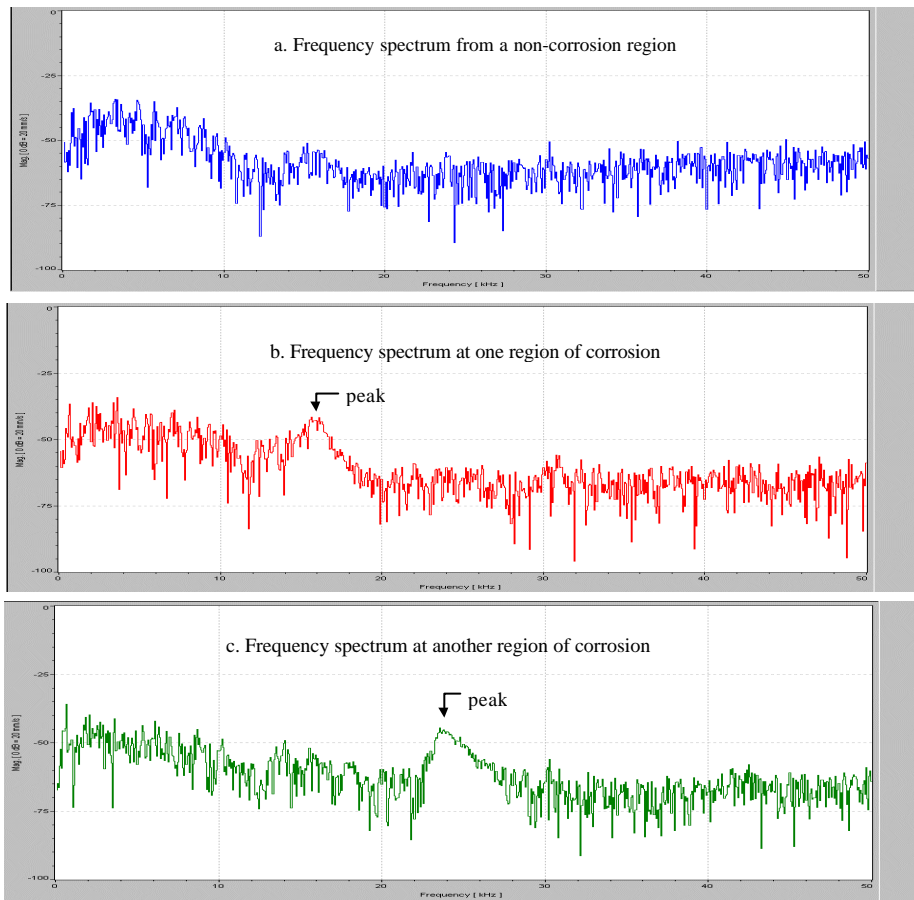
Figure 3: Comparison of frequency spectrums at corrosion and non-corrosion regions

From the data contained in the rich data set on the computer record of the scan, we extracted the FFT spectrum of each data point of the primary antinodes in each of the fault regions. What is to be noted here is that the peak response for each of the different defects is in an entirely different region of the vibration spectrum and relates directly to the metal thinning in that region. Figure 3a shows a normal (non-corroded) response and b and c shows two of the FFT spectra clearly illustrating the peaks due to the corrosion. Figure 4 is a plot of the metal loss condition against the resulting frequency. It conforms to the equation for membrane resonant frequency, w_n , given by⁷:

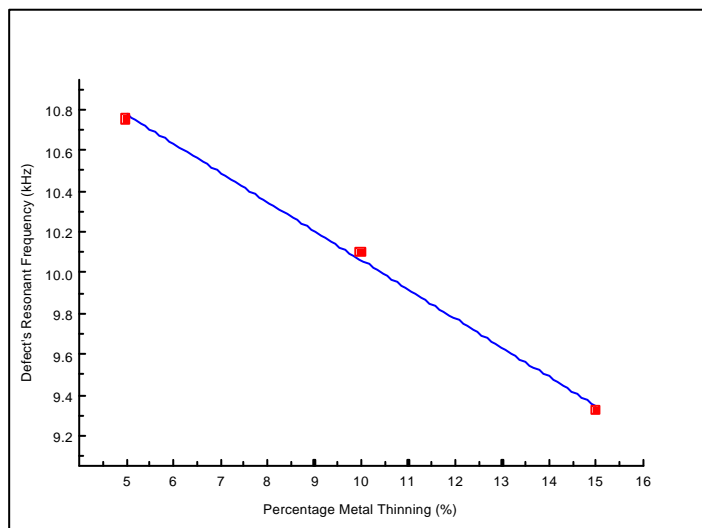
Figure 4: Graph of metal thinning against resonant frequency for the results in figure 2

$$w_n = B \sqrt{\frac{Et^2}{r a^4 (1 - \nu^2)}}$$

where B is a variable dependent upon the shape of flaw and edge conditions, E is the Young’s modulus, t is the thickness of plate, r is the mass density, a is the dimension of plate, and ν is the Poisson’s ratio.
