RAID

Remote Acoustic Impact Doppler

A System for Mapping Structural Anomalies

A new concept in Non-destructive Testing

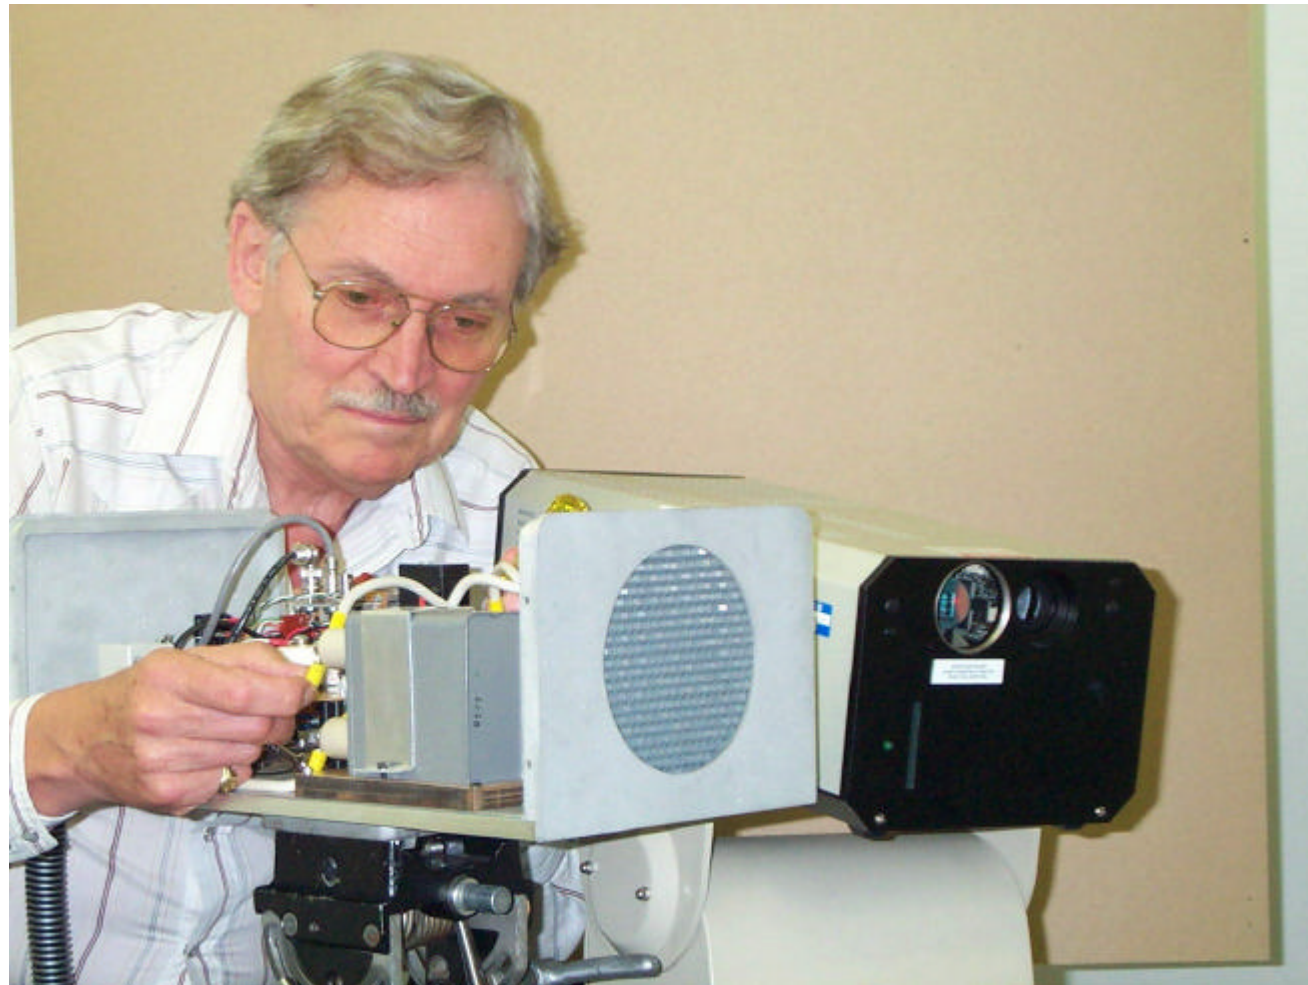
Laser Scanning Vibrometer and Exciter unit.

The exciter unit produces a shockwave that impacts the object undergoing testing, exciting it to produce out-of-plane vibrations at their natural resonate frequencies. These frequencies are directly dependent upon the material, design and subsurface conditions of the structure.

Synchronised to the exciter, the laser vibrometer scans the object, point by point, recording out-of-plane vibration. These frequencies and amplitudes that have been stimulated by a shockwave produced by the exciter. The response to the shockwave of an area of defect will be different from an undamaged area of similar material. After the scan, these frequencies and amplitudes are analysed using a specially designed computer algorithm to show subsurface defects present in the structure undergoing testing.

Laser scanning vibrometer & transducer

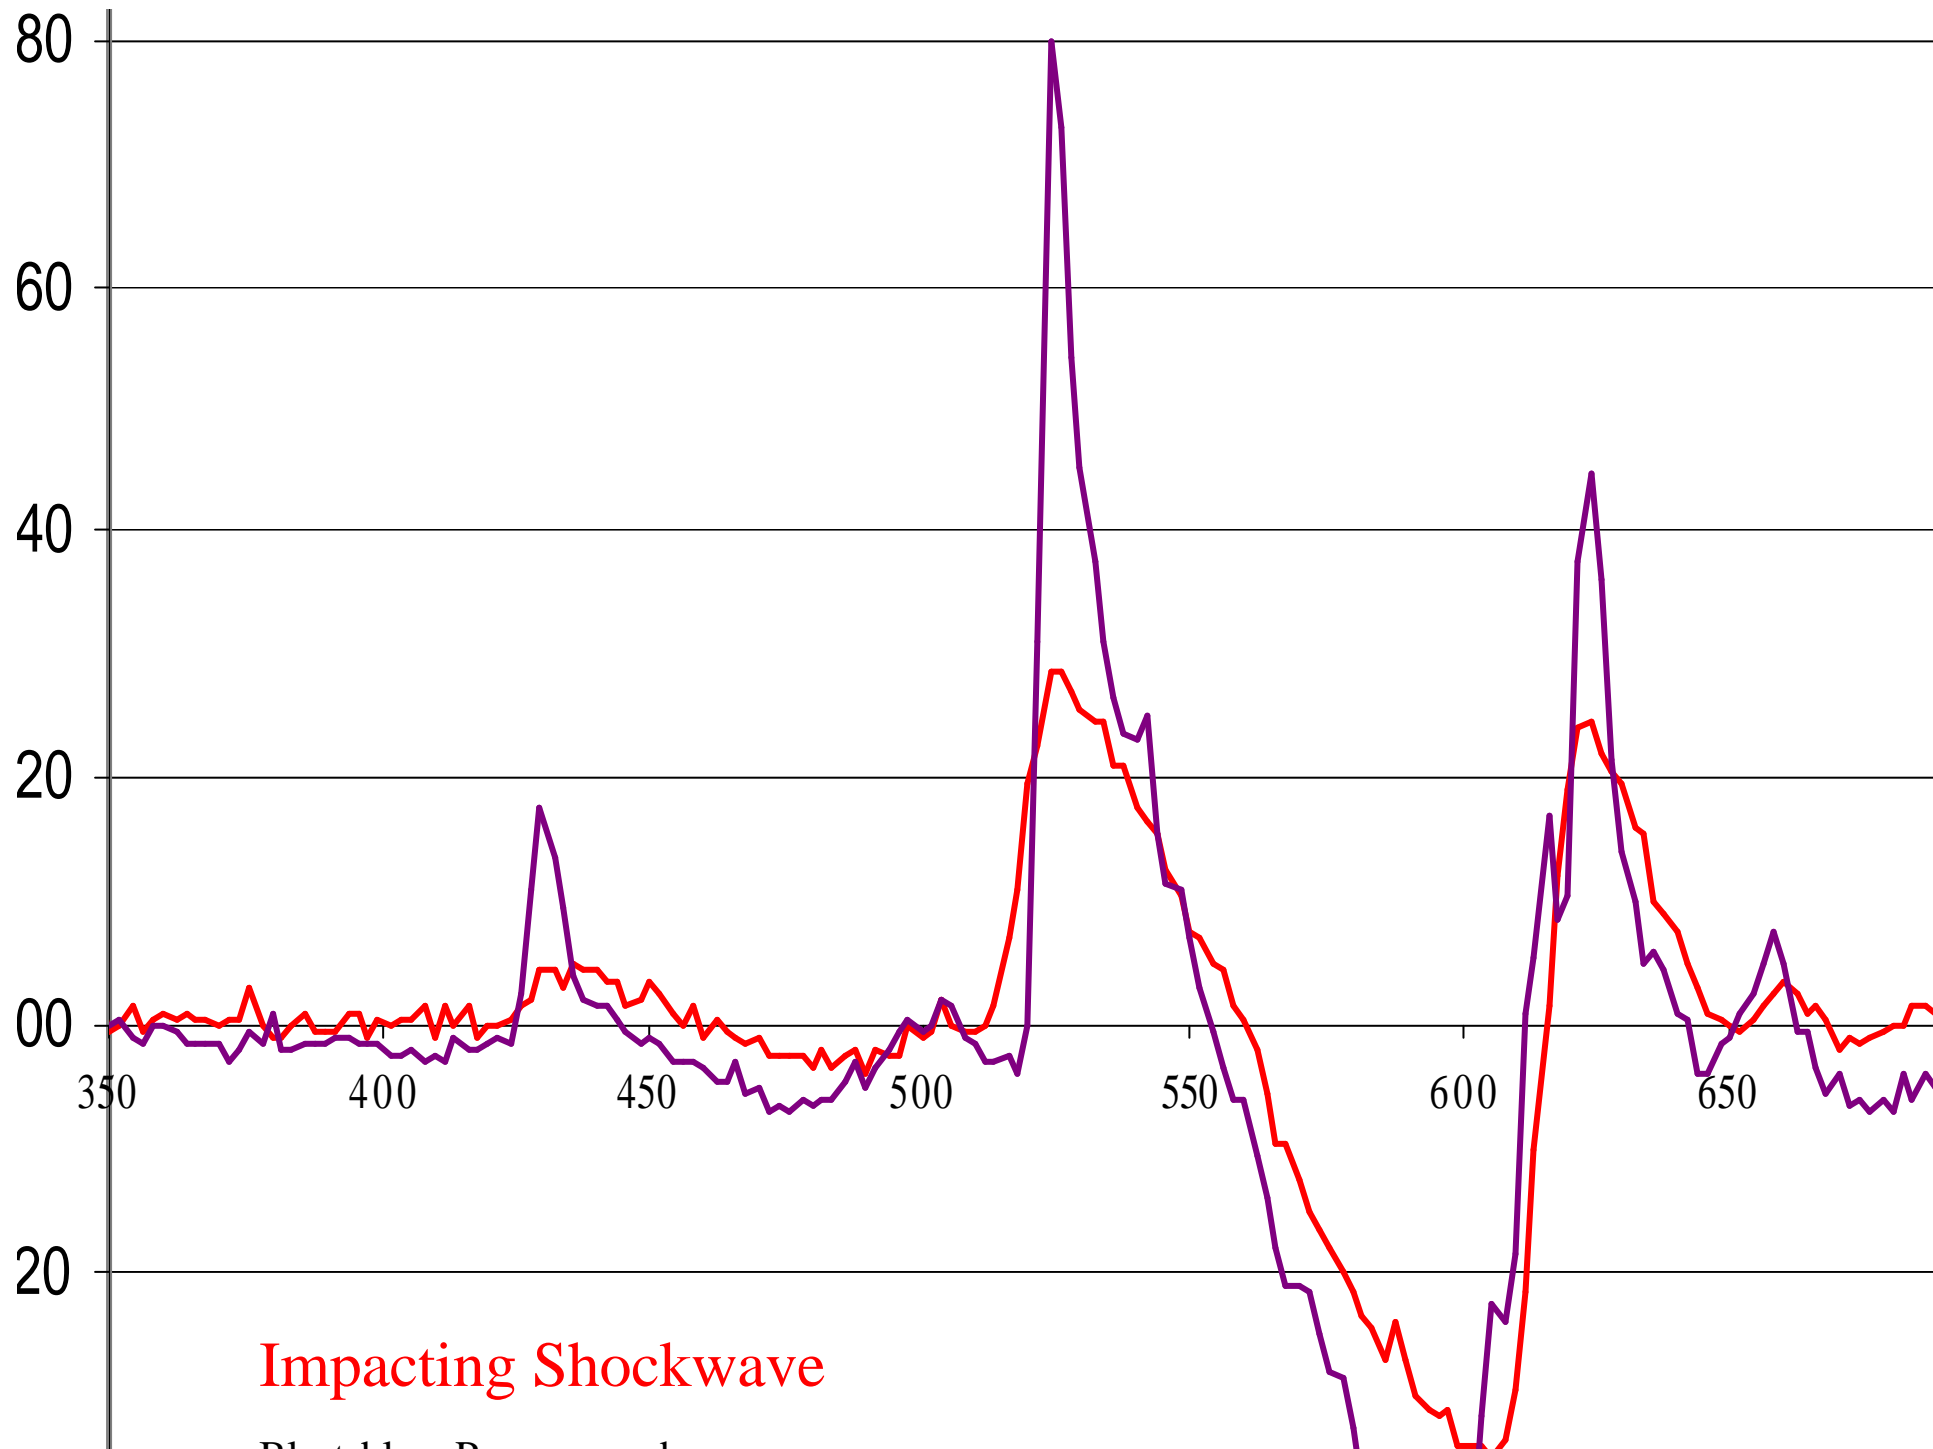
Impacting Shockwave

Plot of Pressure vs. Time

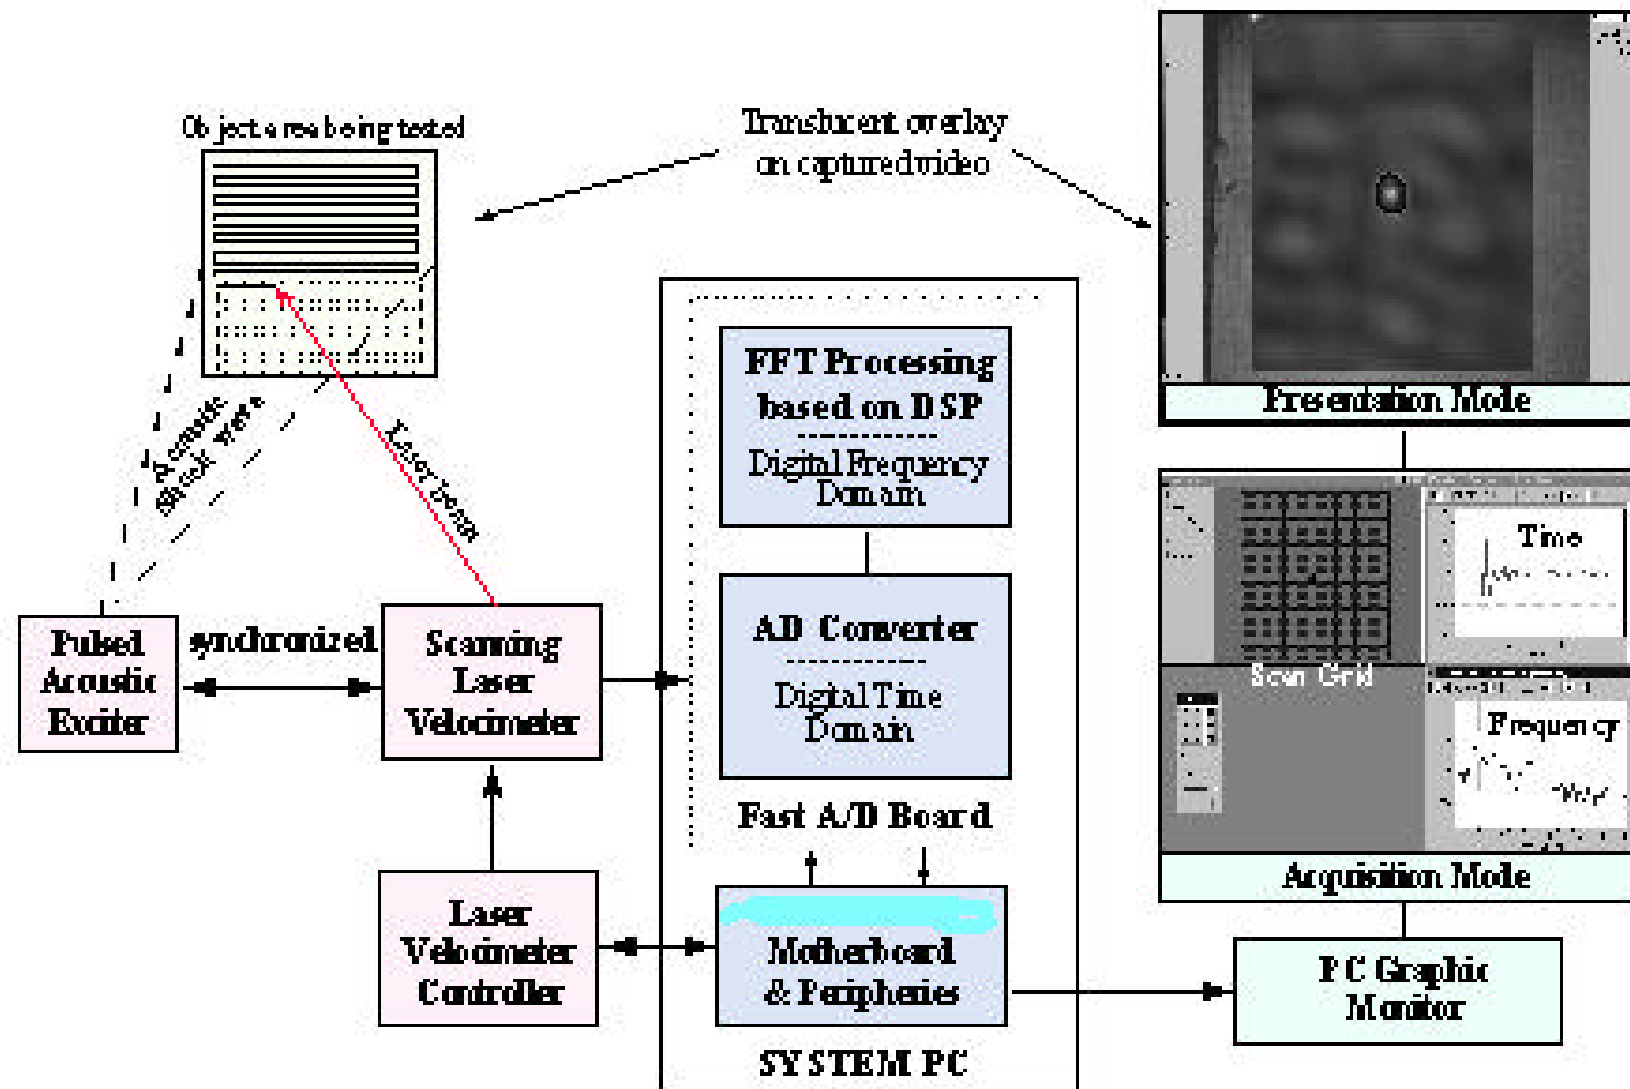
System Architecture

The shockwave impacting the test object is synchronised to the scanning laser. The laser vibrometer, which employs the Doppler effect, scans on a point-by-point basis to acquire data across the surface of the test object. The resulting data is recorded in the form of a digitally time domain trace that is later processed to a Fast Fourier Transform (FFT); an FFT is a vibration spectrum of the data point(s) recorded.

The final analysed result is presented to the operator superimposed on a picture of the object undergoing testing. By simply clicking on any defect present on the monitor the operator can cause the scanning laser to point to the defect region on the test object.

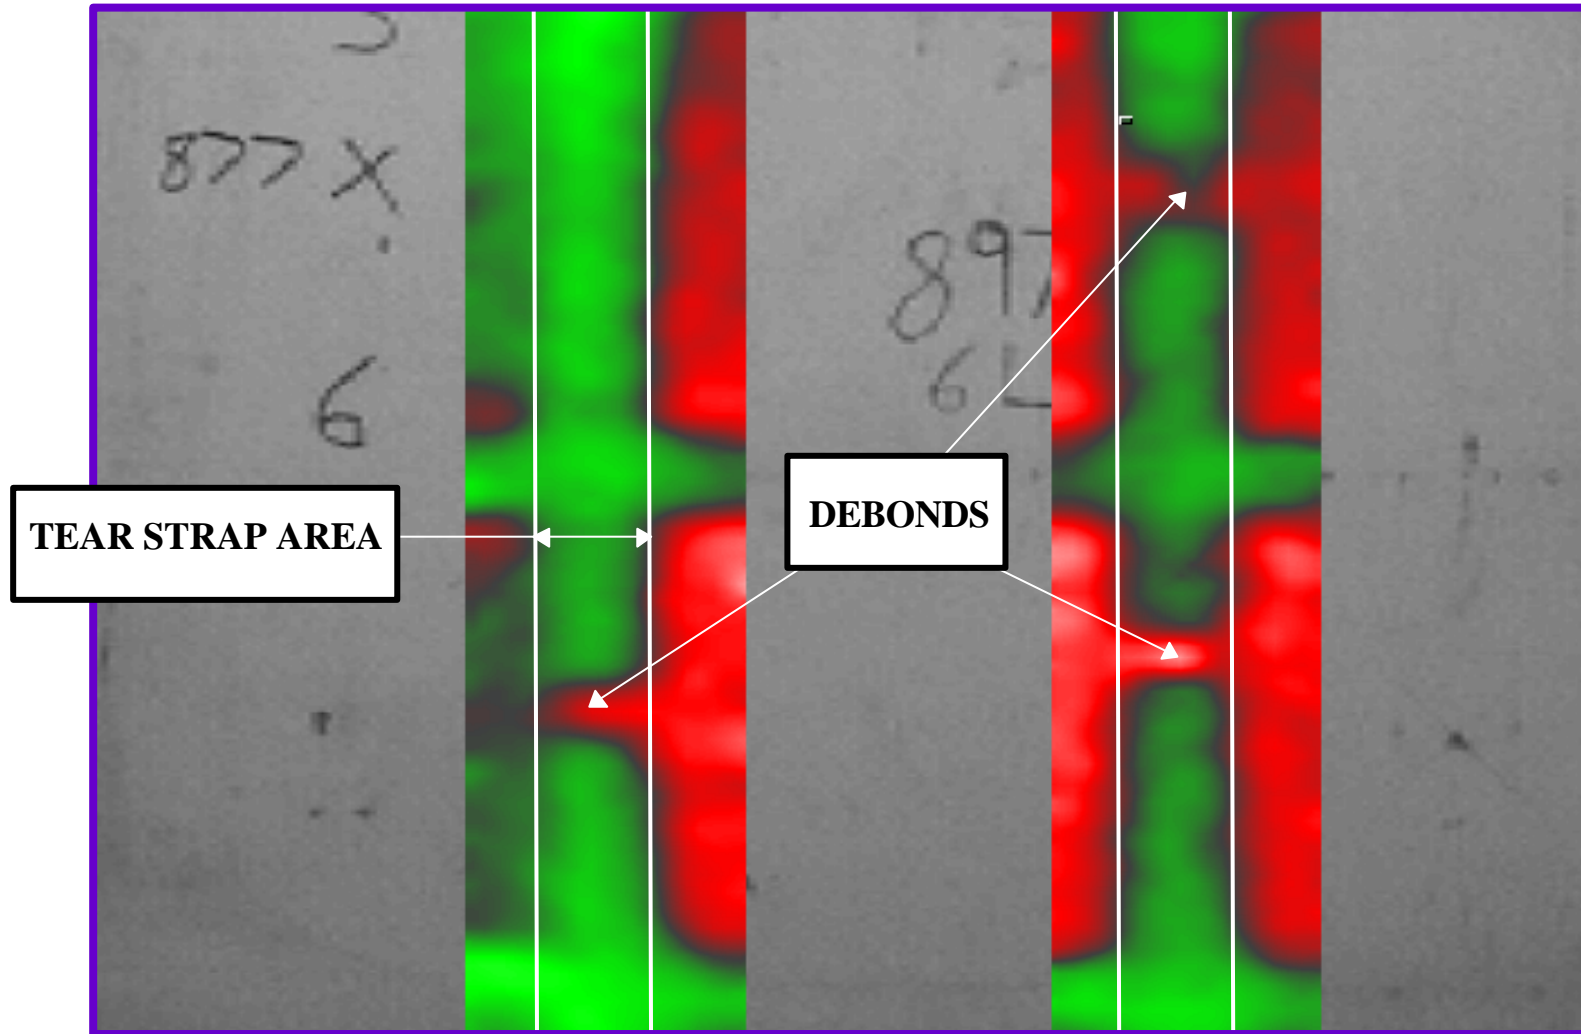
Disbond: Fuselage Tear Straps

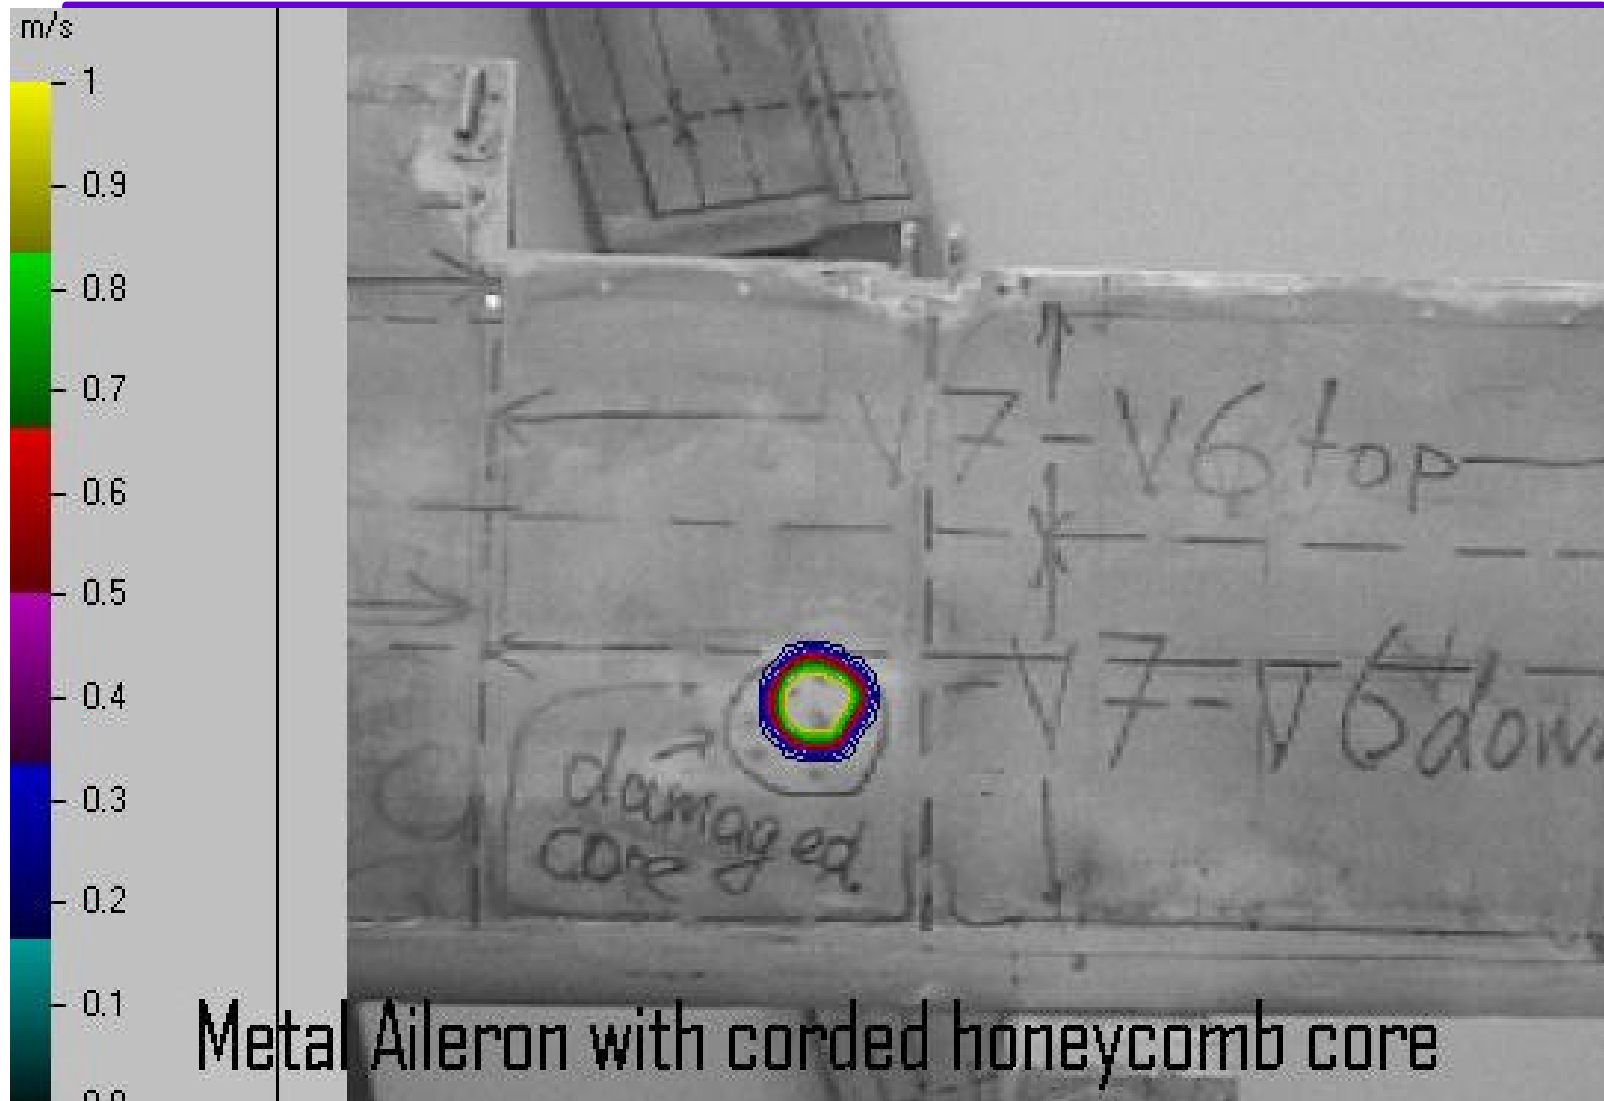
*Skin/honeycomb debond in aileron. Possible cause:
corrosion*

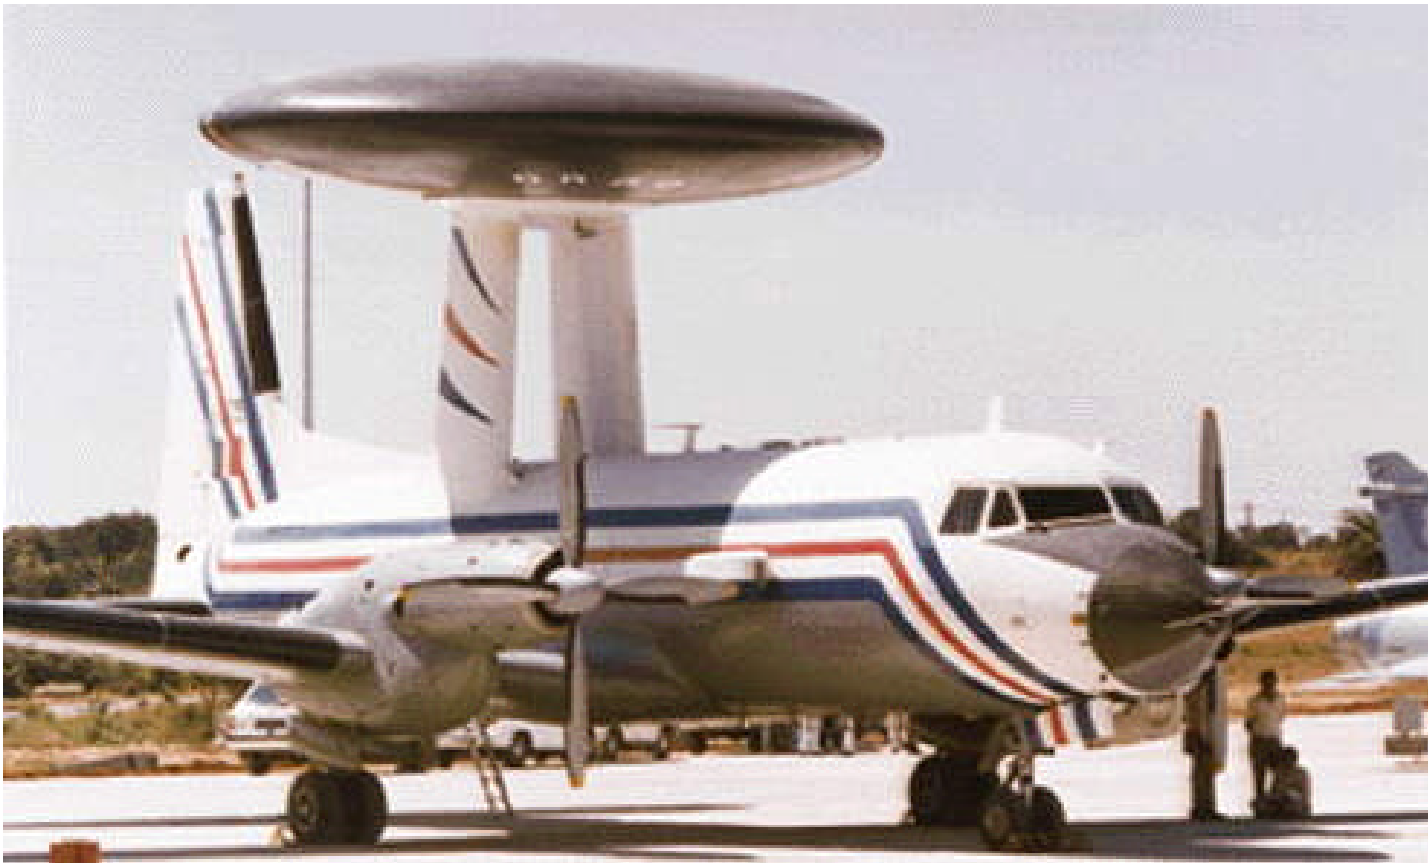
AWAC Navy

The dome is manufactured from a radio-transparent fibreglass material. Consequently, it is relatively soft and susceptible to damage from such incidents as a bird strike or hail impact.

In the example shown, the dome half-section had been removed to the laboratory. However, the dome could easily be inspected in-situ using RAID technology
